ABC OFFICE BUILDING

I. Facility Description

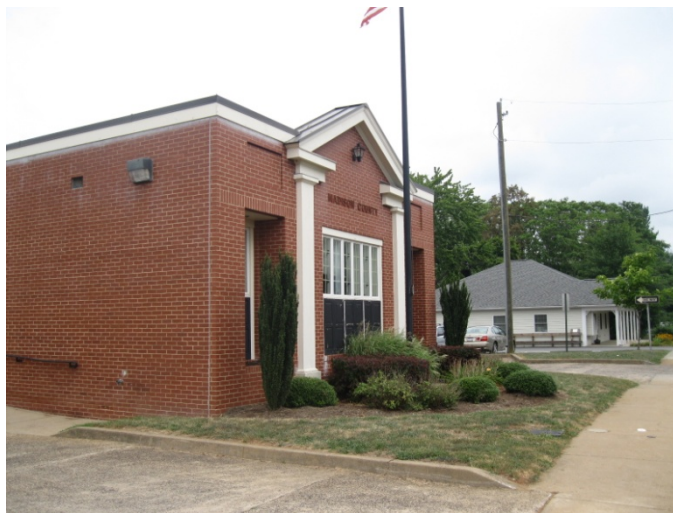
Various county departments have been housed in the facility with interior partition modification and some finish modifications, including carpeting starting in the 1980's and then renovated in the 90's as the Clerk Office.

Date of construction is assumed to be in the 1960's for a commercial store. The brick exterior, masonry interior wall section is not expected to have insulation. The facility is a single story brick veneer building with a built up roofing system. Floor is a concrete slab on grade, with three entry points. Two are via a set of concrete steps and the third is via a handicap accessible concrete ramp system.

The building has a masonry foundation with concrete slab on grade and thickset terrazzo flooring in good condition with few cracks.

Brick masonry – good condition with some areas requiring minor re-pointing. The windows appear to be double paned insulated glazing with exterior metal storm/screen systems. There is also some wood exterior trim at windows, doors and entries including the small wood framed canopy at the rear entry. Wood shutters have been installed below the metal clad windows at the front of the facility. All exterior wood should be thoroughly inspected for rot, prior to the recommended re-painting.

Original built-up roofing, age unknown, with a spray applied polyurethane foam roof (PUF) system applied on top, in various stages of deterioration. Existing downspouts are metal and need replacing.

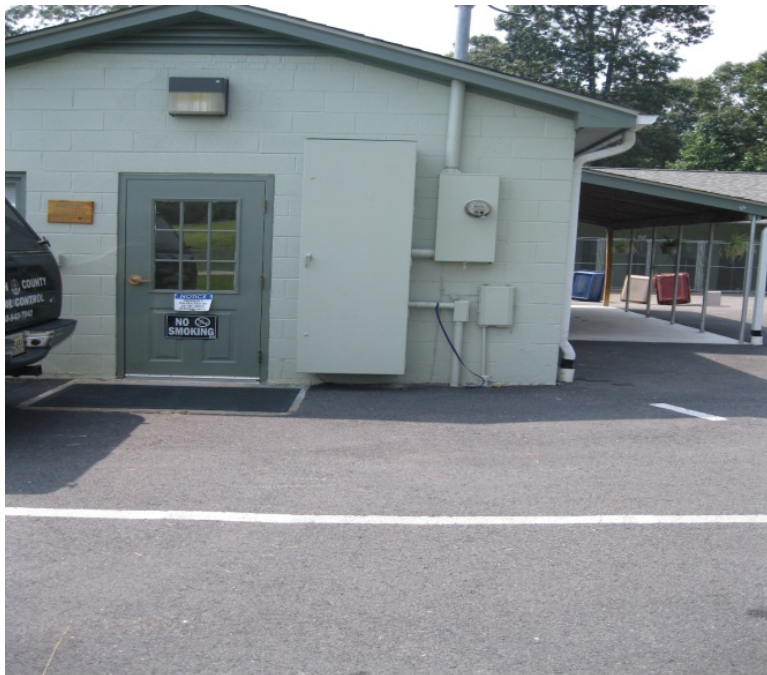
Renovations to the existing facility were completed in 2005 and included replacement of existing windows, masonry restoration and interior painting and a new addition.

The single story masonry bearing building supports the wood framed truss roof. In the new addition, the 8" masonry block is insulated. The windows are vinyl double-hung insulated glazing except in kennel area where vinyl awning windows were used. All shed roofs and outdoor runs are framed with wood joists and beams. All roofs are covered with asphalt shingles with aluminum gutters and downspouts. Since the addition is recent, the roof is in good physical condition.
